Feasibility study, preliminary design and programme for preparation of main design for decrEase of flood risk of regional road Tetovo-jazince by pOrojska reka

Presenter: Ivan Blinkov

Hans Em Faculty of Forest Sciences, Landscape Architecture and Environmental Engineering (HEF), - UNISCM

SETOF workshop June 16th-17th, 2022 in Skopje, Republic of North Macedonia

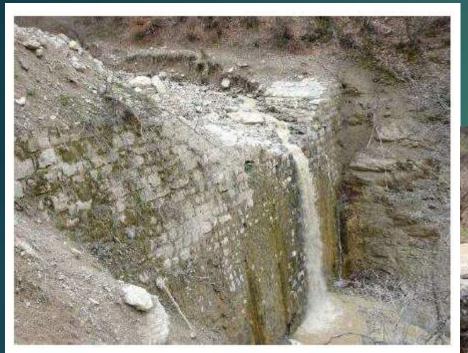
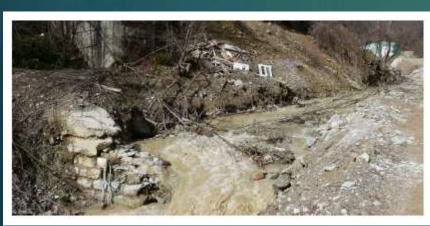
- ► Check dam from the 50,s
- ▶ Hk < 10 m and rests of small check dam

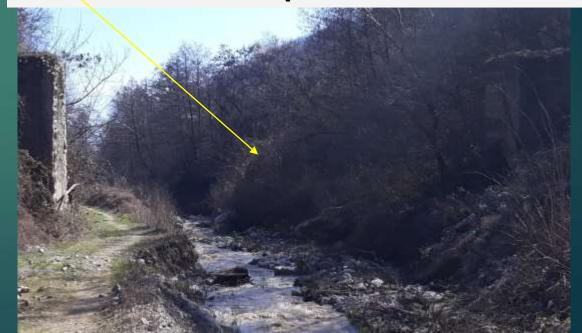
Rests of Former Open Check Dams

- ▶ 2 in the 50,s canalizing of the torrent bed , classical closed check dams, all made by stone in cement mortar
- ▶ 3 in the early 70,s construction of open check dams Herheulidze type
- ▶ These open check dams were destroyed later 1979 and later. Causes for this were: huge discharge, big boulders probably the biggest one registered (cca 30 m³), and low quality of construction (used local material, and concreting was done in situ that result in low concrete grade.

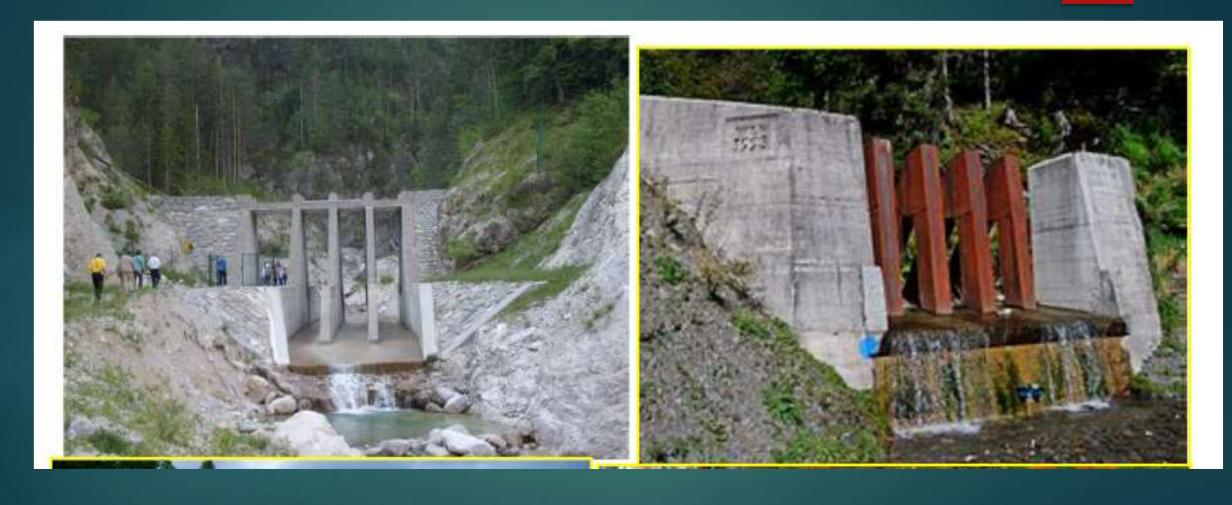
## The most upstream dam

Open dam - for stopping the biggest boulders (steel or armature concrete)

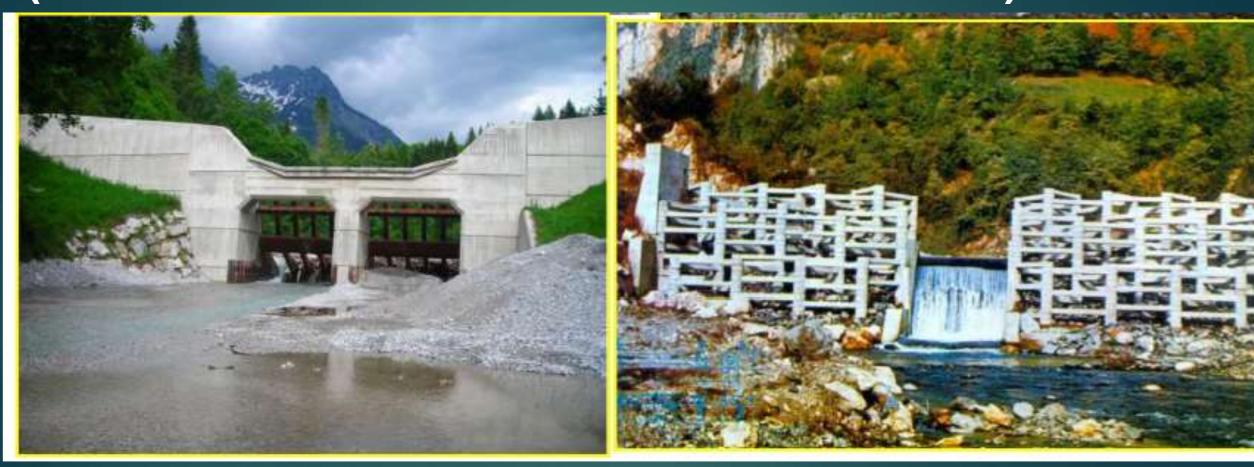
## The mid check dam - lattice construction (steel or armature concrete or combination)

Open dam - for stopping boulders

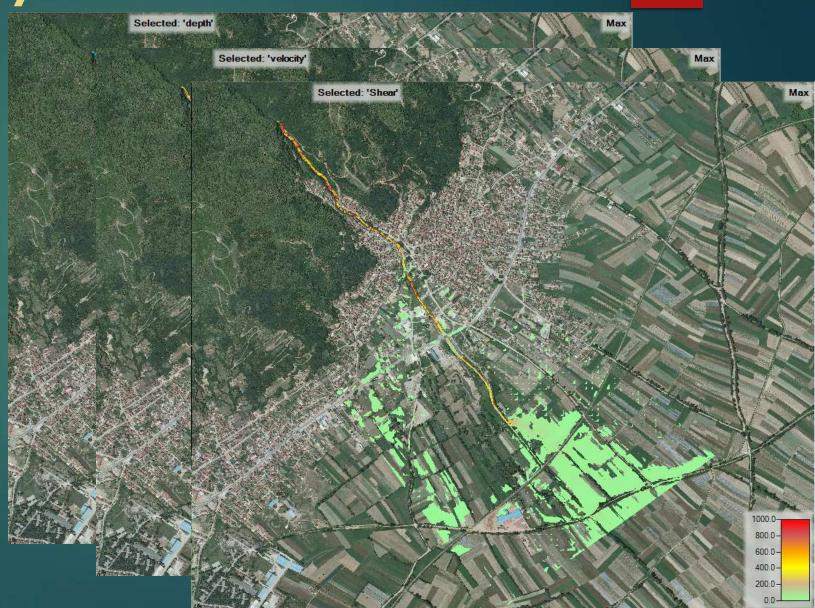
- > WATER DEPTHS
- > VELOCITIES
- > SHEAR STRESS

- The natural riverbed of the Porojska river in the village of Poroj in current conditions (state 2020), has a capacity of about 100 m<sup>3</sup>/s. This is due to the large longitudinal slope which is about 7%.
- The local floods upstream from the bridge on the regional road Tetovo Jazince occurs due to the narrowing (clogging) of the river in the zone of the existing bridges and the pipe culvert.
- The bridges in the village of Poroj, and especially the bridge on the regional road Tetovo-Jazince have a capacity of about 80 m<sup>3</sup>/s
- Maximum calculated velocities of 12 m/s (15 m/s) and shear stresses of 800 N/m<sup>2</sup> (1000N/m<sup>2</sup>) indicate destructive erosive forces that caused erosion in the riverbed and transport of sediment downstream.
