Soil Erosion and TOrrential Flood
Prevention: Curriculum Development at the
Universities of Western Balkan Countries

Rapid diagnostic of the catastrophic event happened on 3rd August in the Polog region

Workshop on Bachelor and Master Curriculum Best Practices - North Macedonia
28-29 October 2019, Skopje

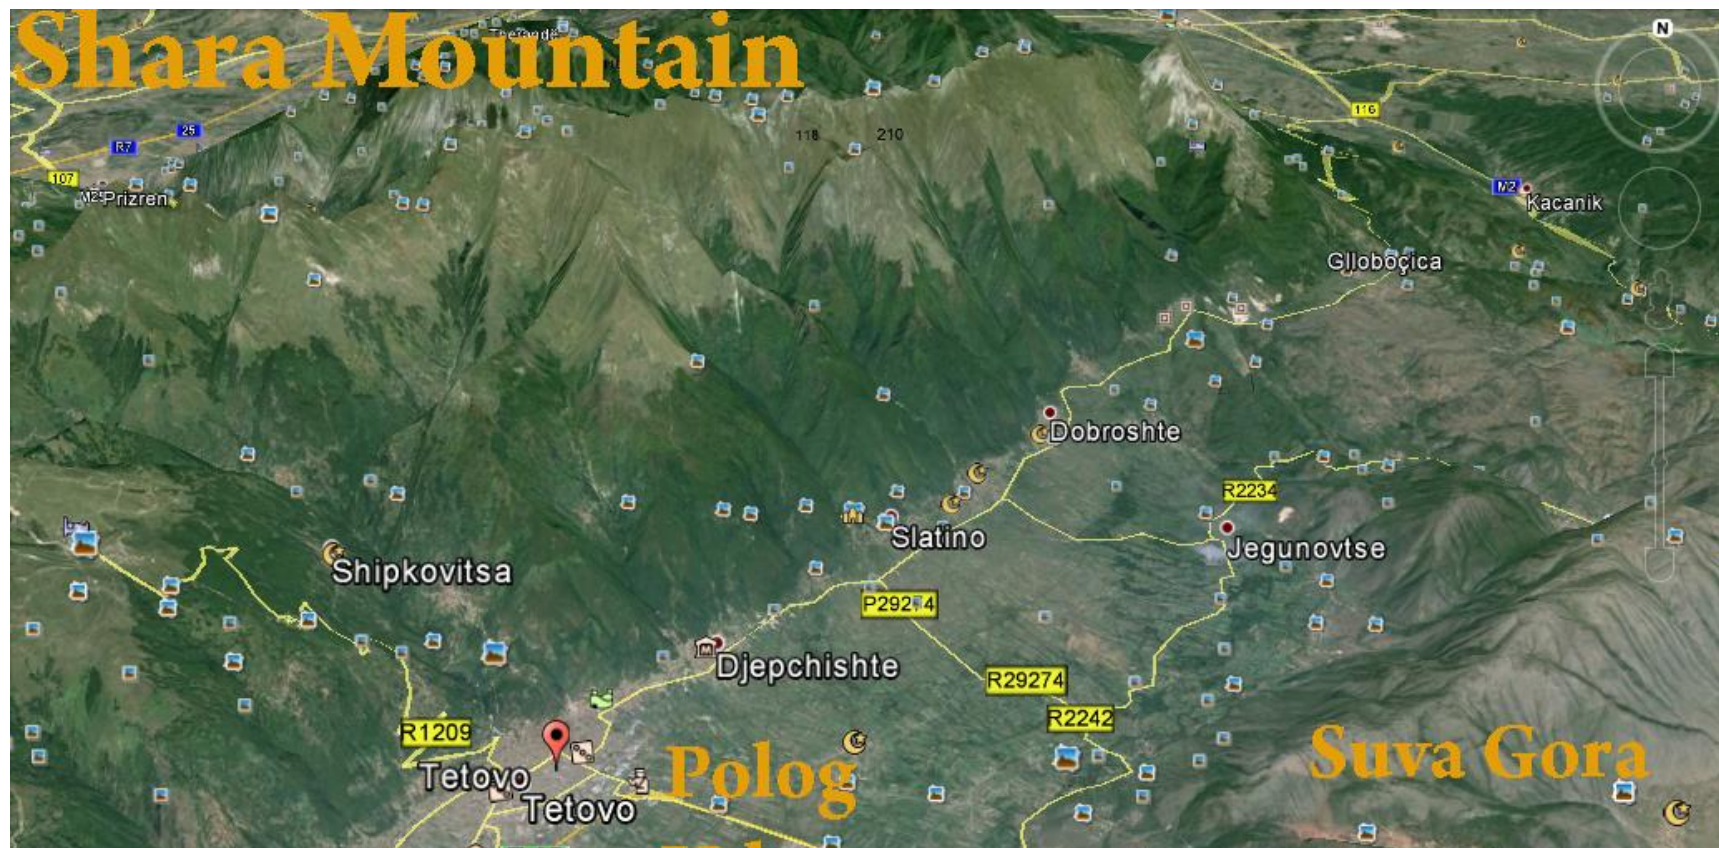
West Macedonian Tectonic zone . A part of the Dinarides “ Young” mountain .(50 Million years).

It is one of the highest in the country (top Turcin, 2.748 m)

Relief shape - Variscan and Alpine orogeny, Karst relief; Glacial relief ; Periglacial relief, Fluvial ((a lot of small and a few larger mountain streams dominantly with torrential character).

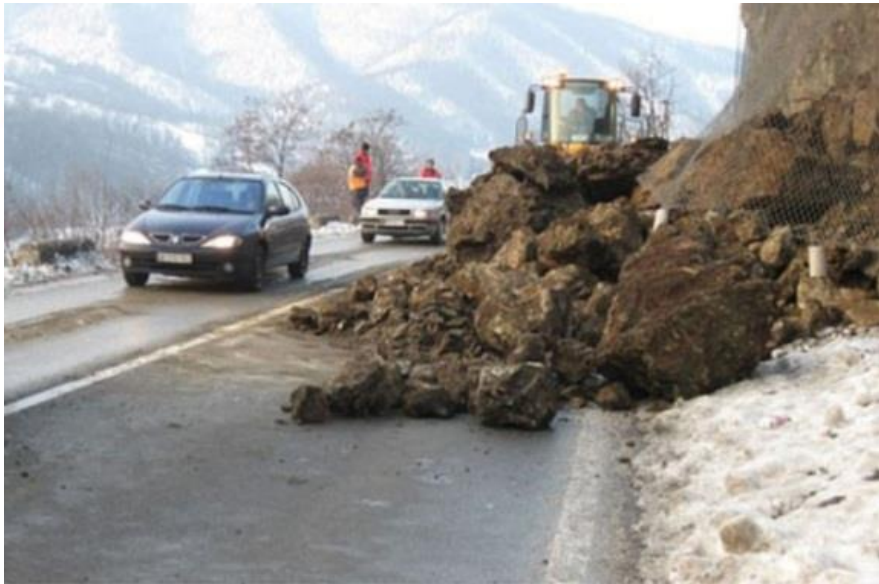
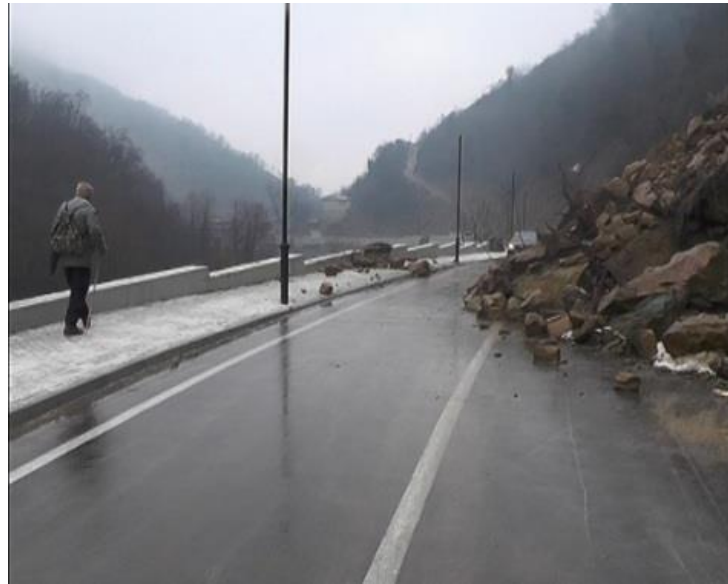
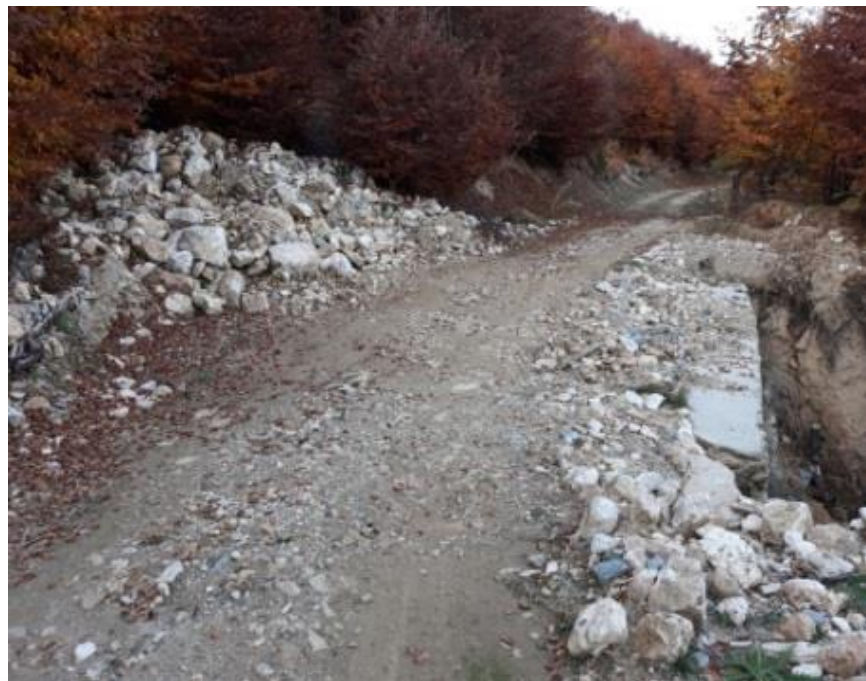
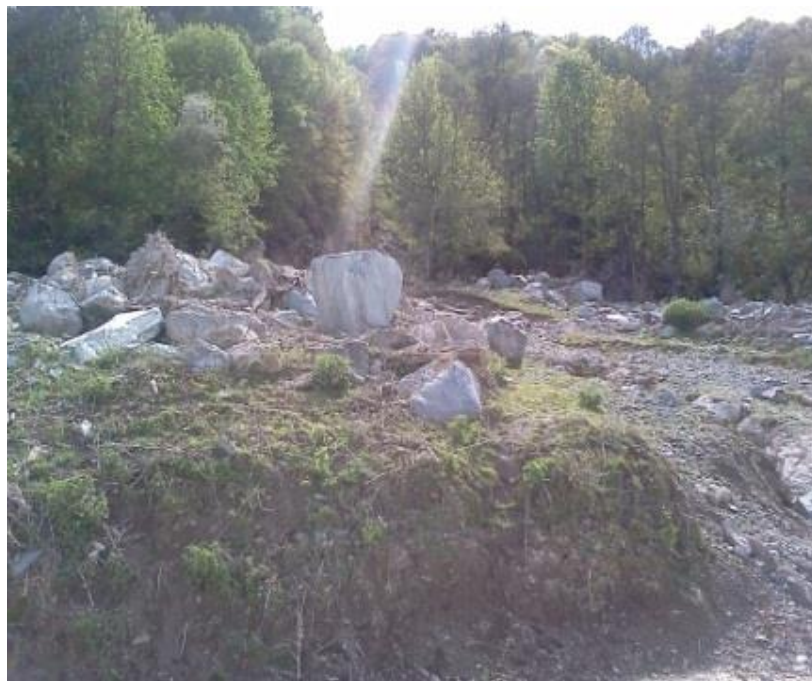
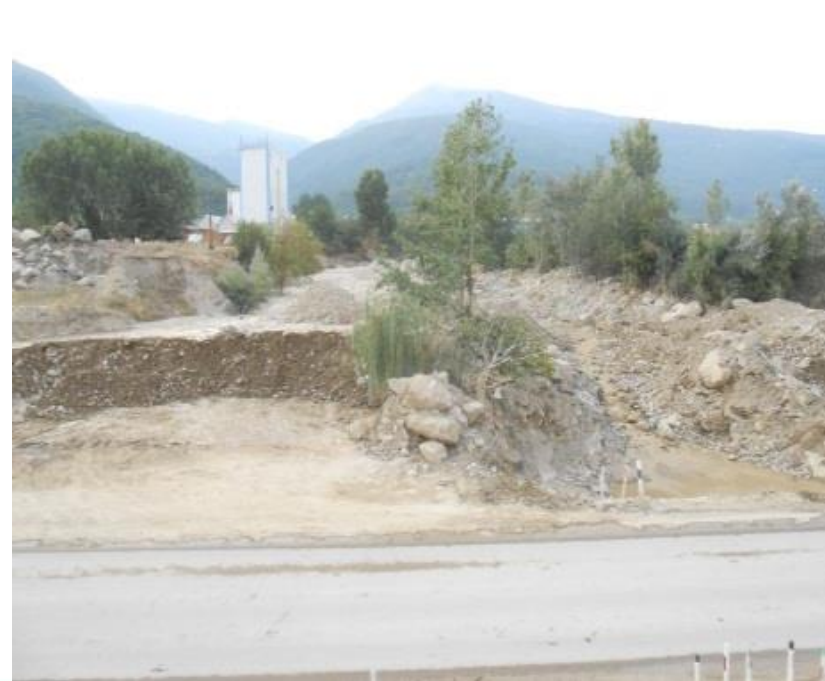
All natural factors favorable to appearance of:

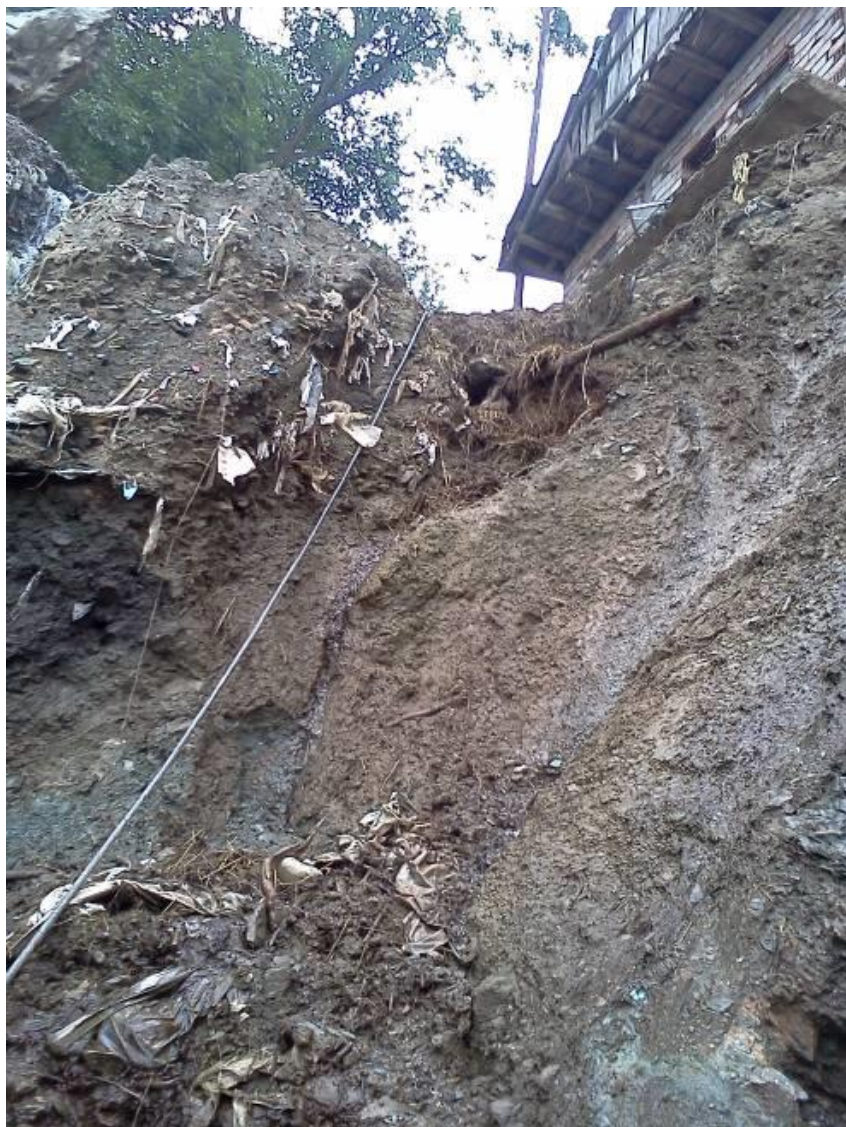
- Land management activities (insignificant changes)
- Urbanism (location of the settlements)
- Construction activities (bridges??)
- Urban plans, hazard/risk maps
- WASTE (various types of waste into the torrent bed)
- Torrent control works in past

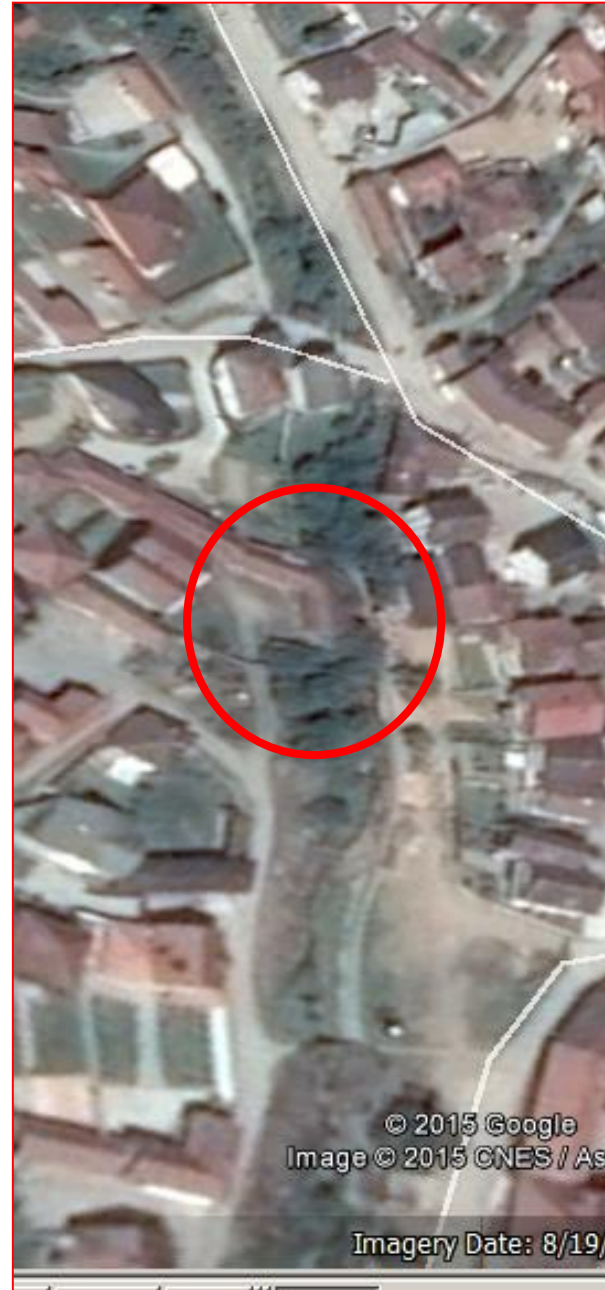
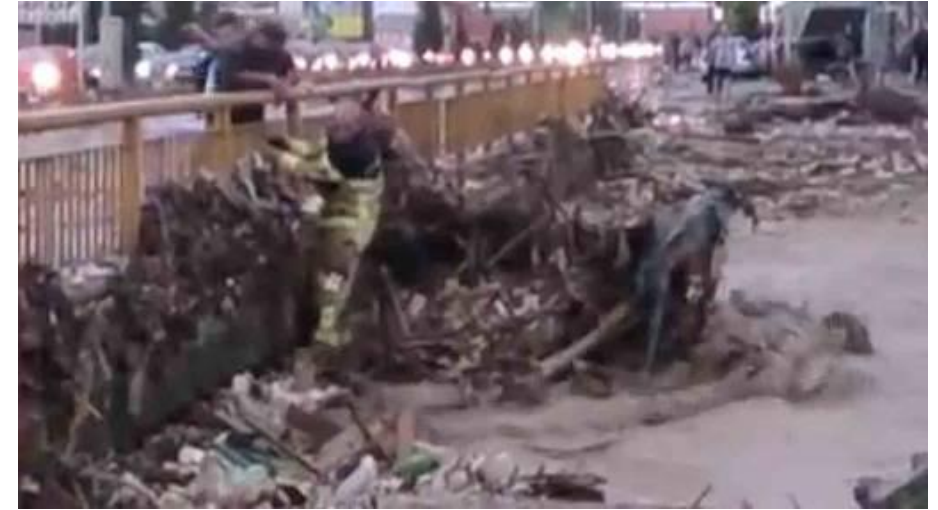
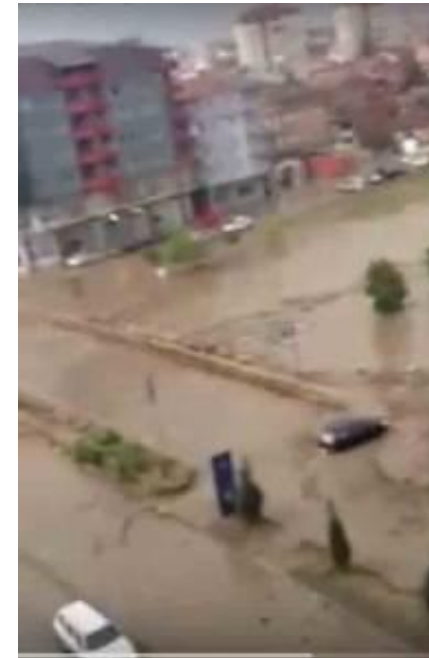
BRIDGES

No Urban Plans for villages
Structures close to the bed
or into the bed and
hazardous area.

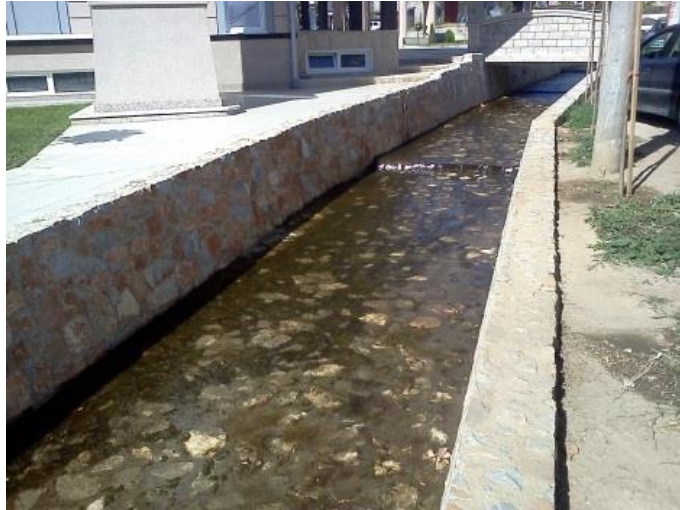
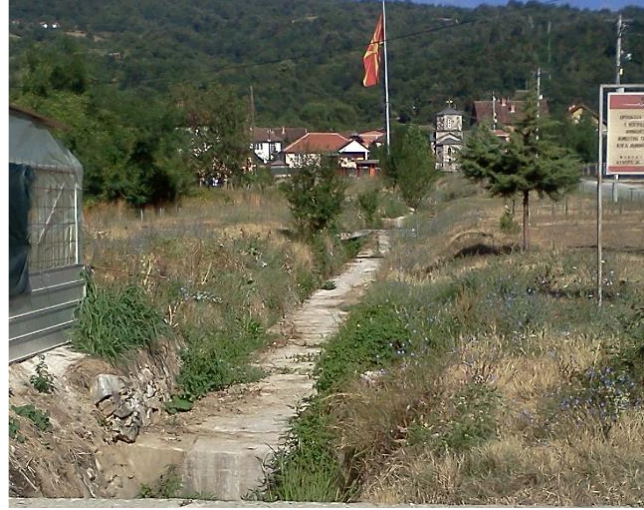
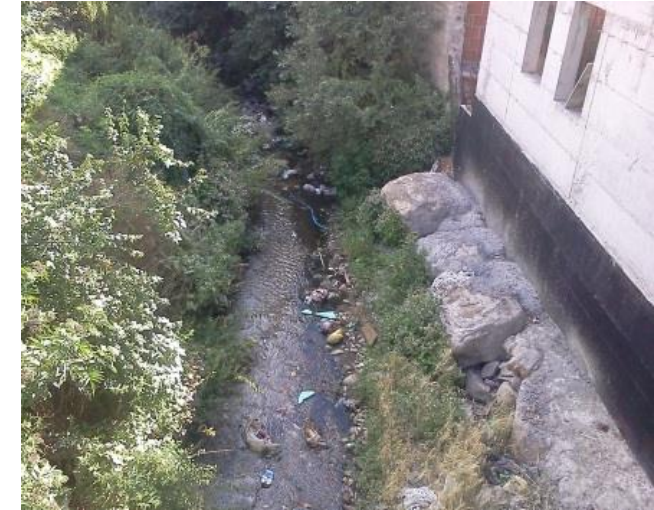
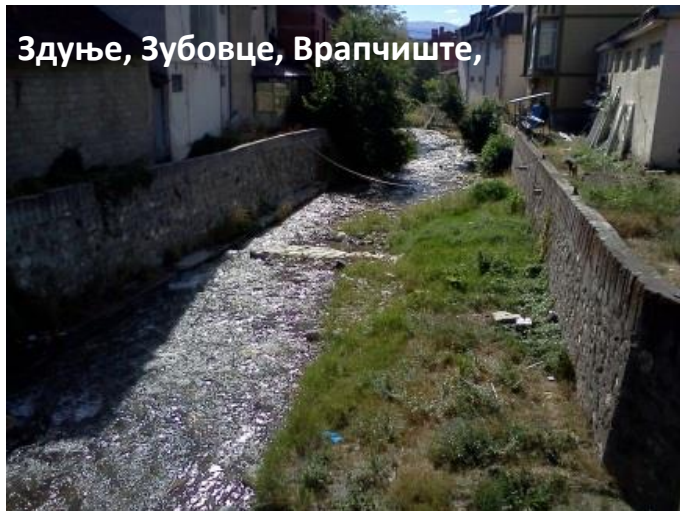
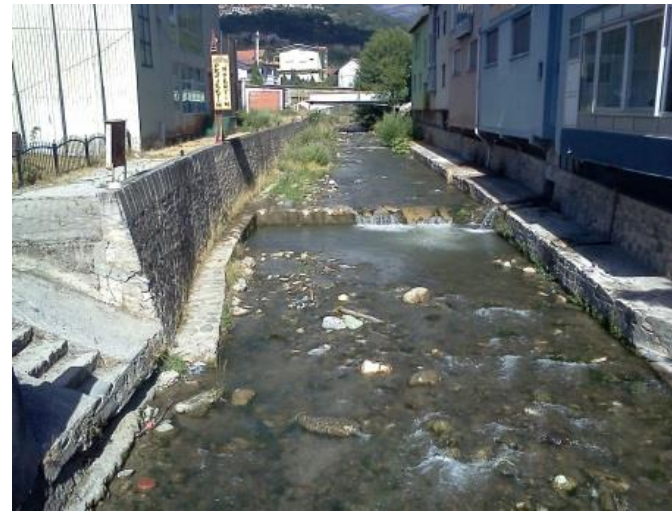
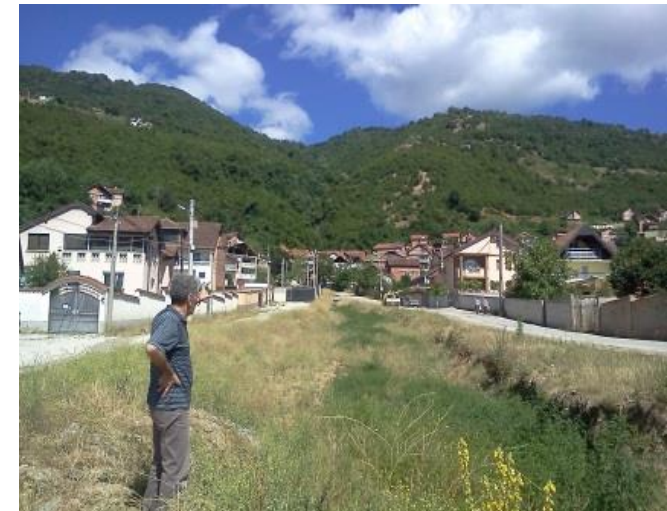
Torrent control in the past

- The first works started in the 30's after the big flood in river Pena and torrent Poroj. No exact data for other torrents.
- After the big flood in the region in the 1979 when significant part of the previous structures were destroyed, started new torrent control works.
- Irakli Herheuldize (ex USSR – Georgia) visited the region and recommended screw-dams (наносоуловители).
- In the Pena river bed – system of 6 screw-dams
- In the Poroj torrent bed – system of 4 screw-dam (destroyed later)
- In Neproshtenska torrent bed – 1 screw dam
- Screw-dams in Poroj due to construction direct on field (not enough strength of the construction) were fully destroyed in any previous debris flow.
- Screw-dams in Pena were built with concrete parts produced in factory however due to huge force of the fluid were damaged (the 1 – highest is almost fully destroyed, and nr.3 significantly damaged),

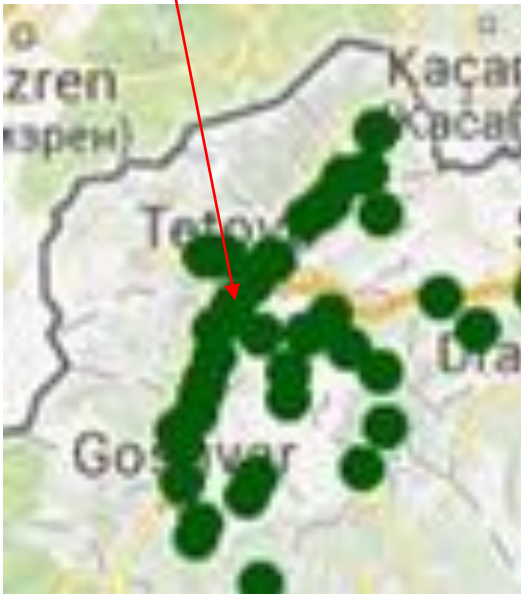
Past floods in the region

- In November 1979 happened floods in the whole country including in this region. City of Tetovo was significantly affected by river Pena.
- In the chronicles is mentioned big flood in the 30' of the XX century.
- “Poroj” – the most significant torrent in the country – big floods 1932?, 1979, . Various floods – 2002, 2003, 2004, 2005, 2006, 2008, 2010, 2015, 2016,2017.....

Personal memories – floods and huge sediments in the 70's and 80's

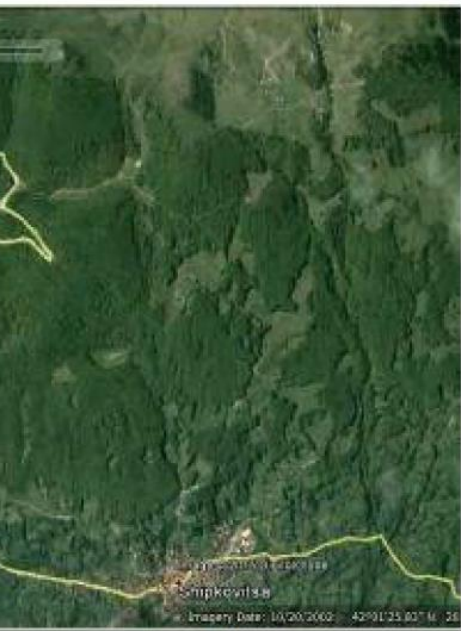
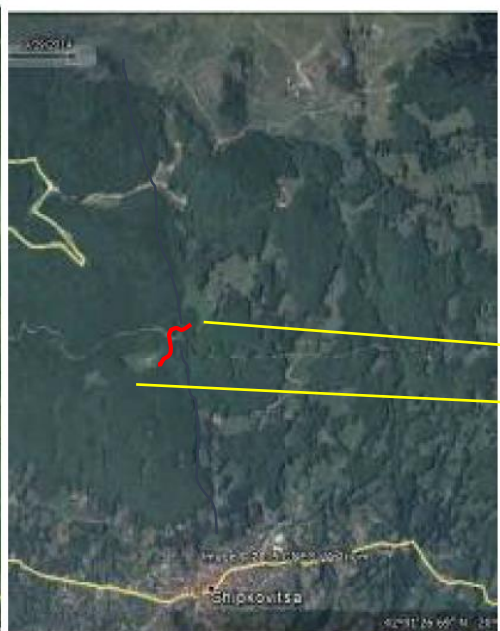
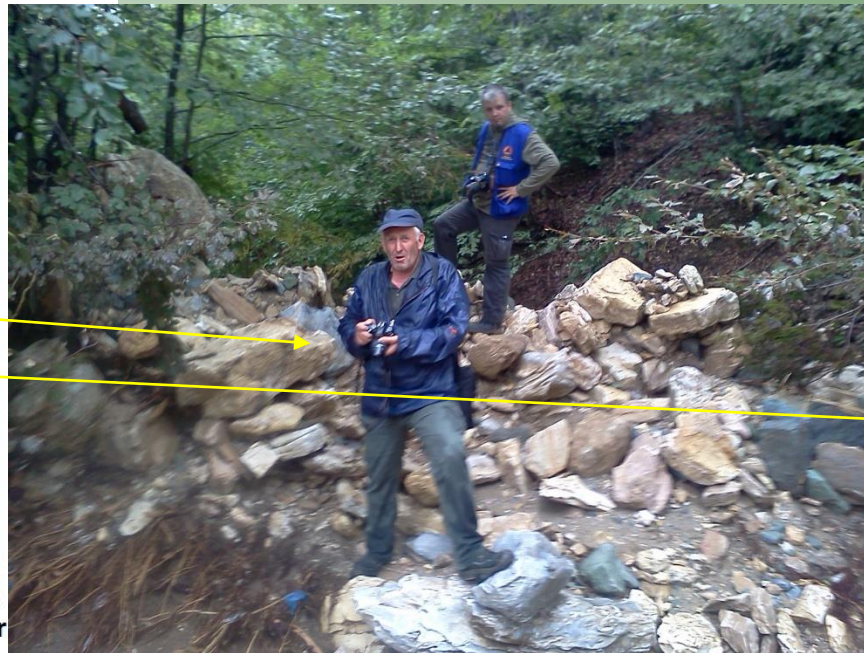
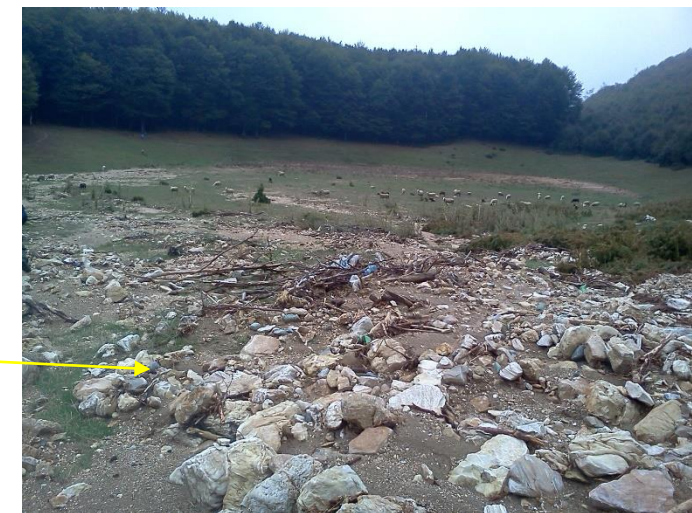
- Total catchment area – $A = 160 \text{ ha}$ ($1,6 \text{ km}^2$)
- Forest cover - 50 %, dense beech forest, other high mountain grasslands
- Forming flood wave on the upper part of the watershed, then intensive fluvial erosion in the main torrent bed

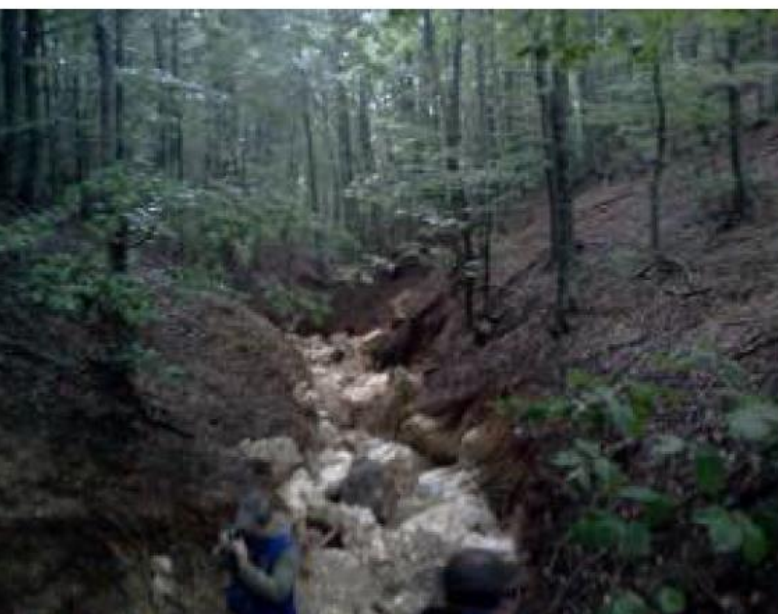
Figure 45 - Gully into dense forest

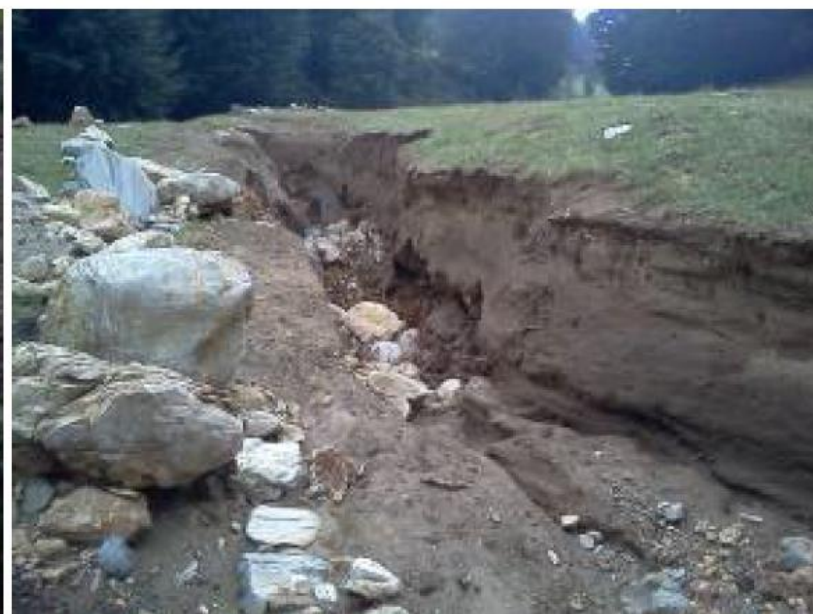
Figure 46 - Gully on the grassland (section 1-2)

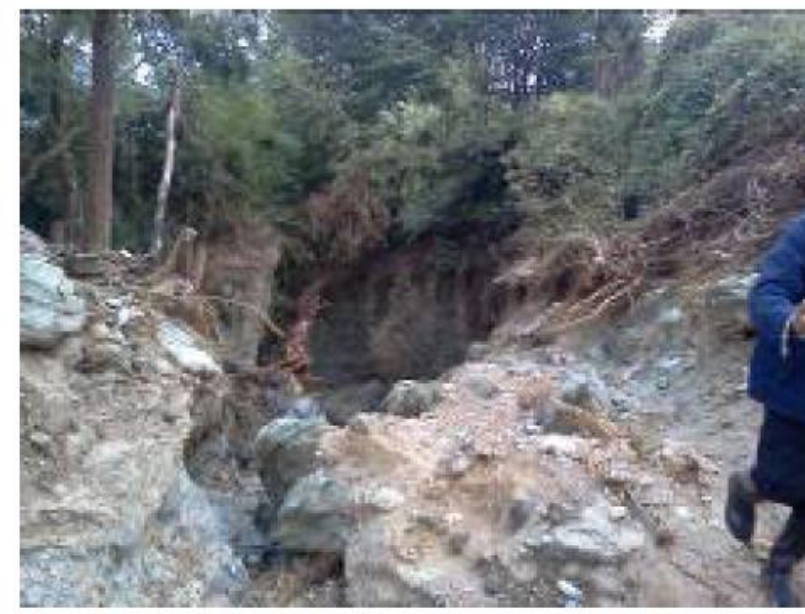
deep gully (cca 300 m upstream of the village) - (3)

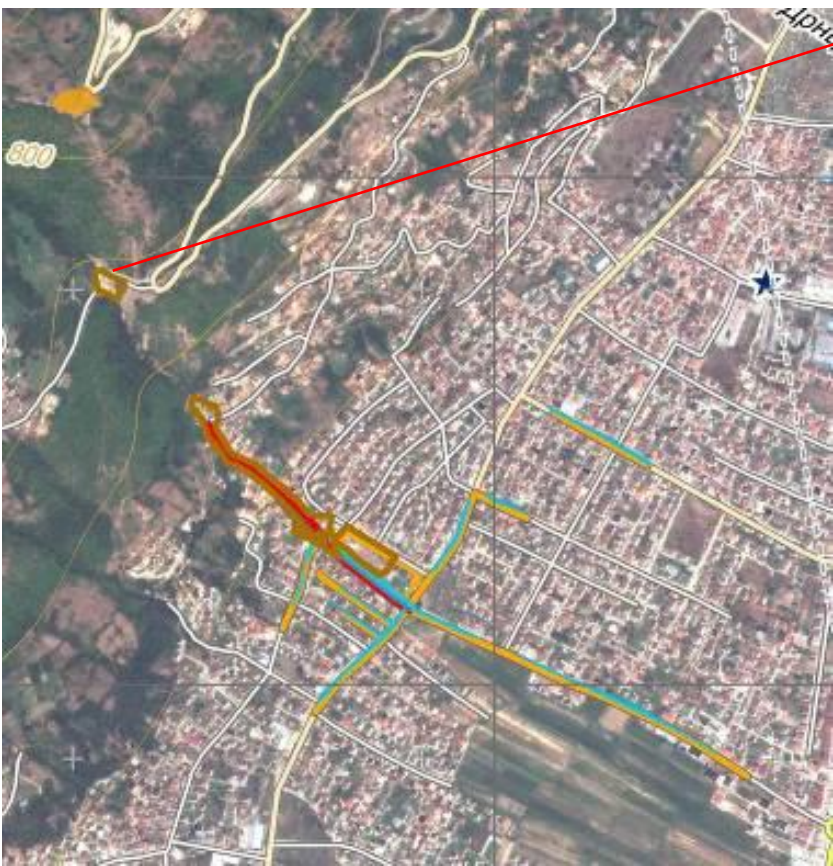
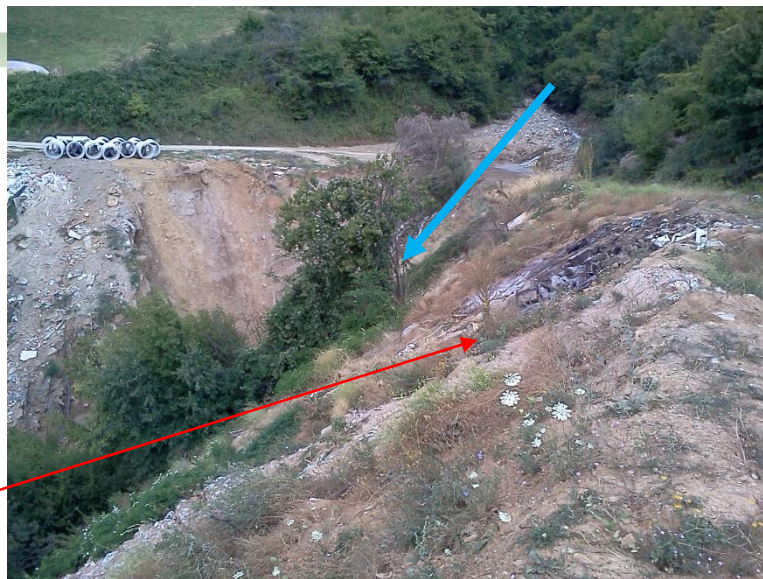
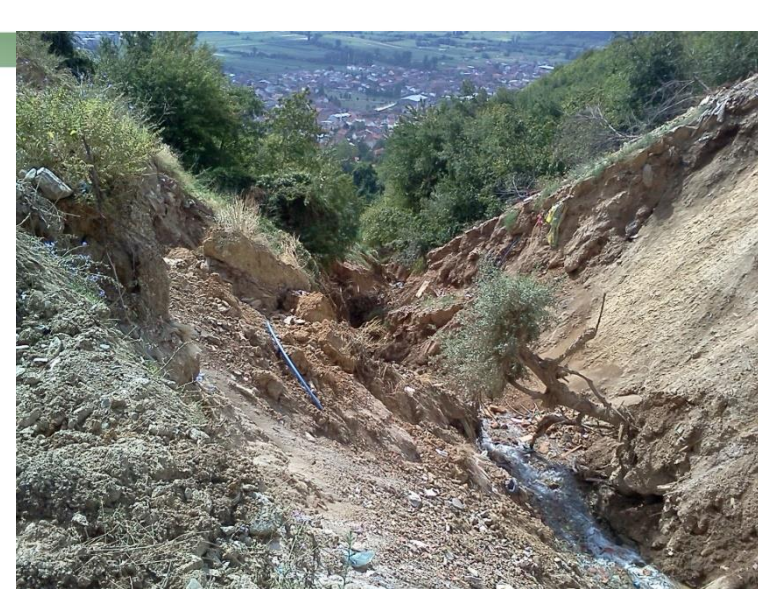
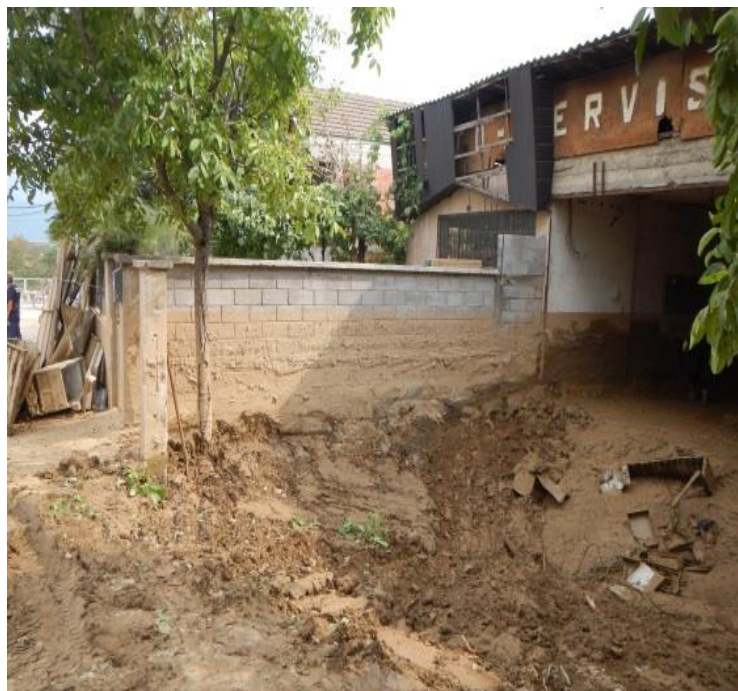
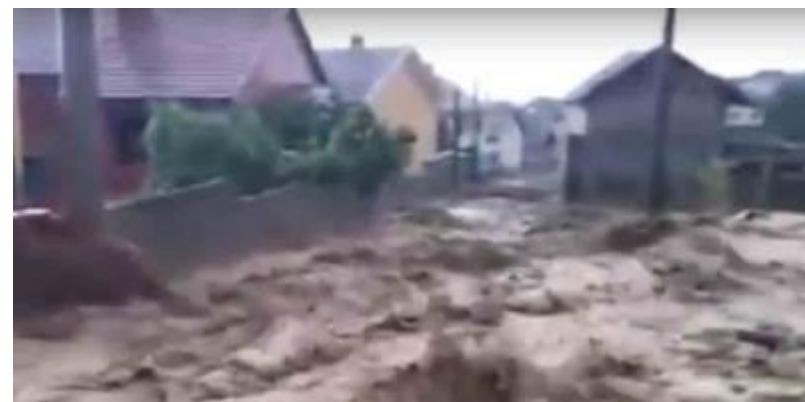
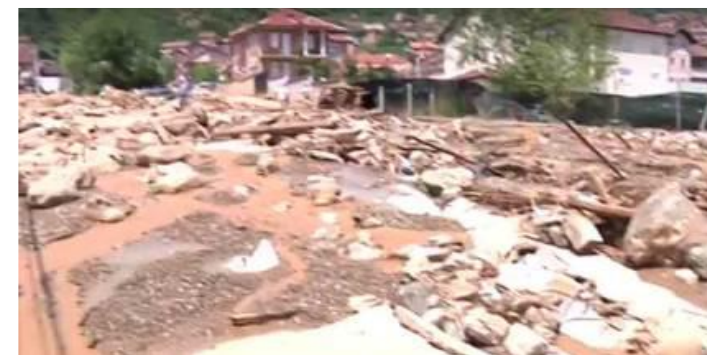
Mala Recica 2 fatalities

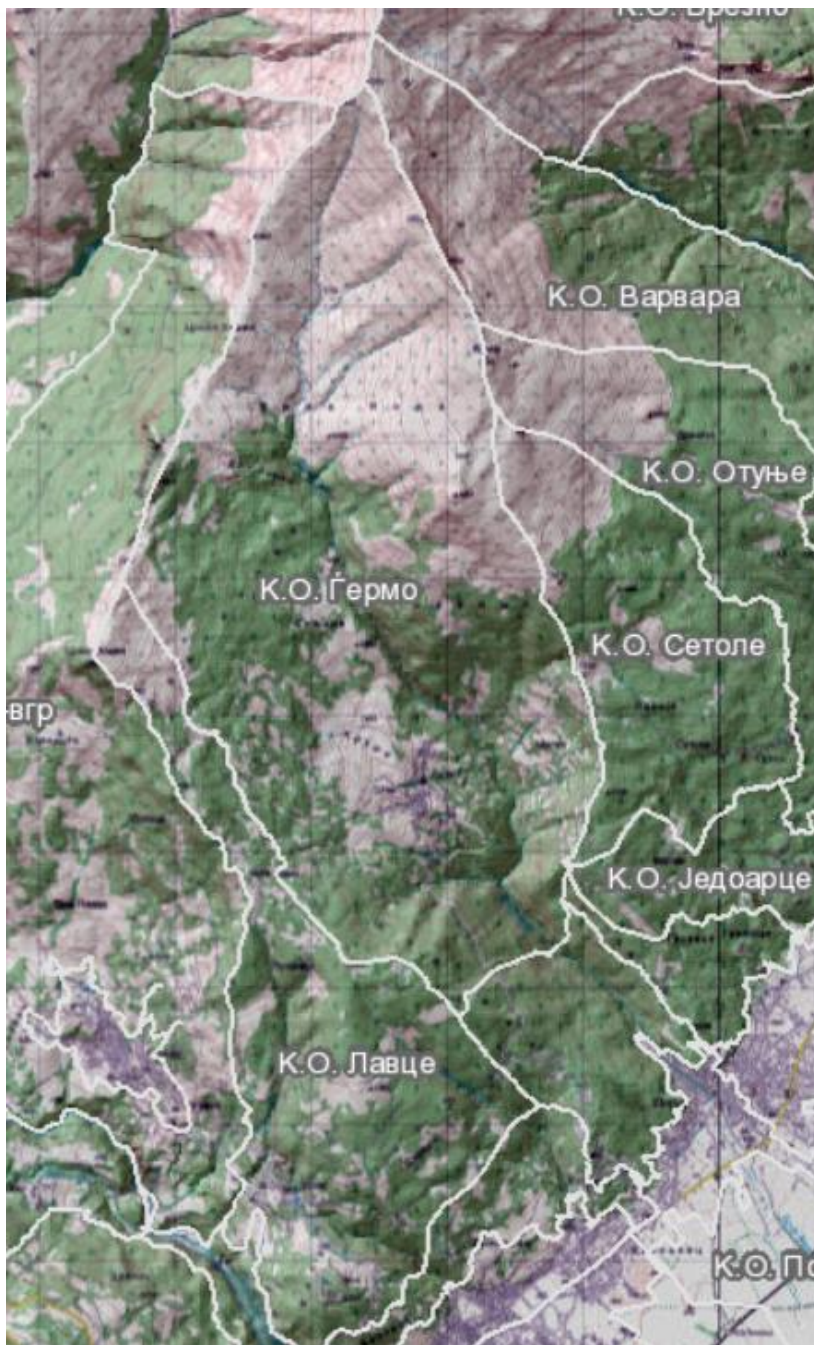
Village Poroj

no one house in hazard area

- Catchment area – 1200 ha, 1b >20%, up to 50% altitude from 480 – 2375 masl
- 50% forest cover
- High mountain grasslands, meadows, agriculture area
- Floods - 2002, 2004, 2005, 2006, 2008, 2010, 2015, 2017

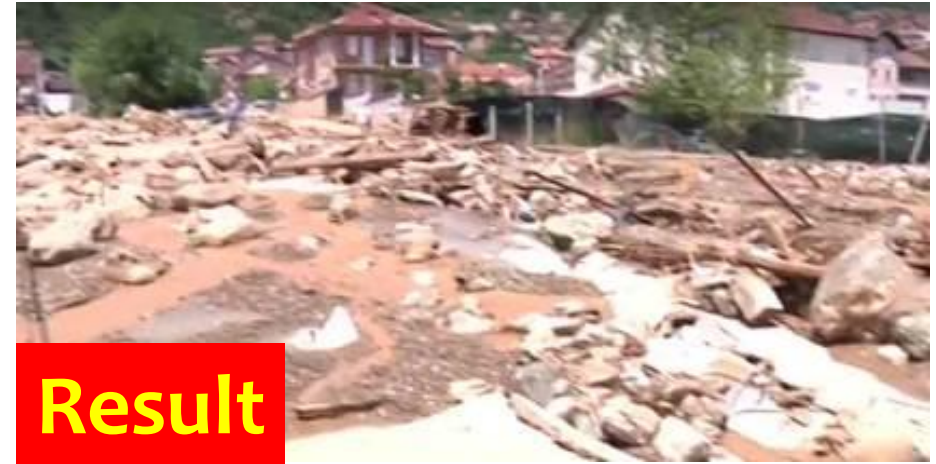
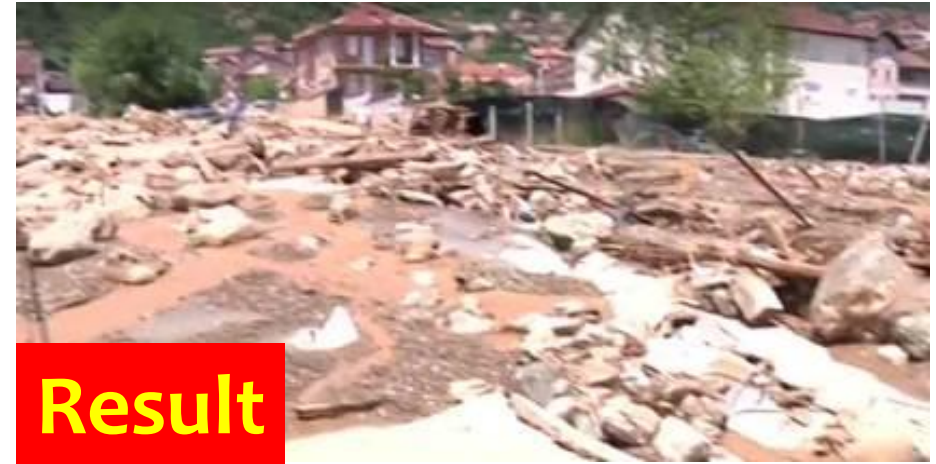
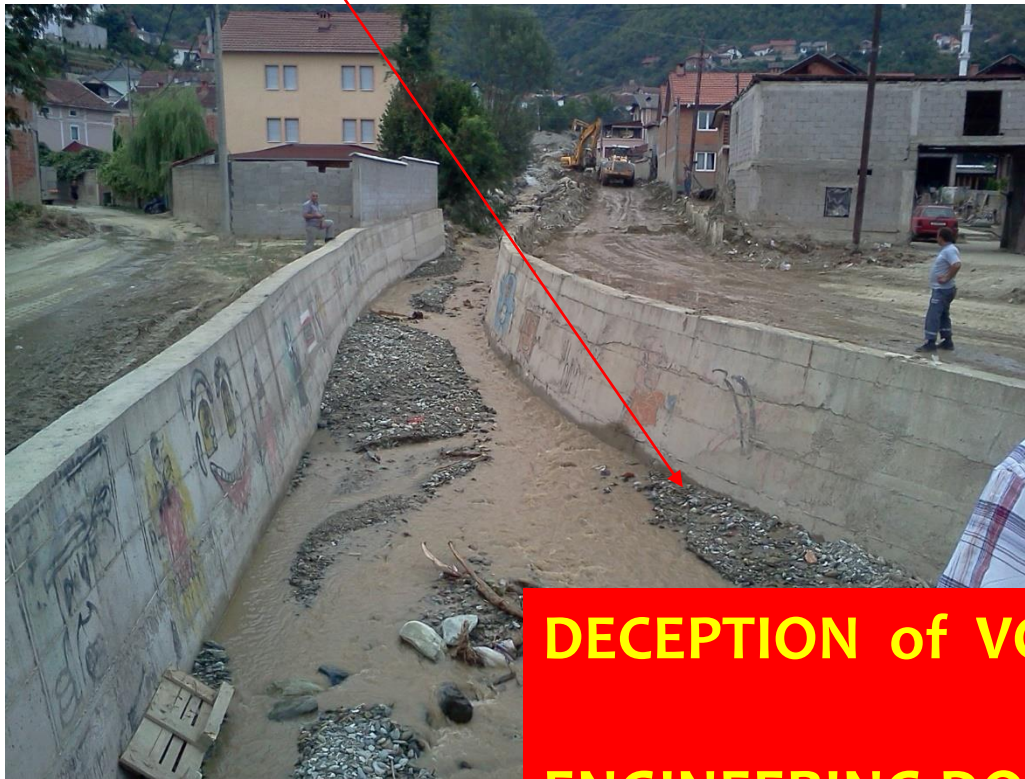
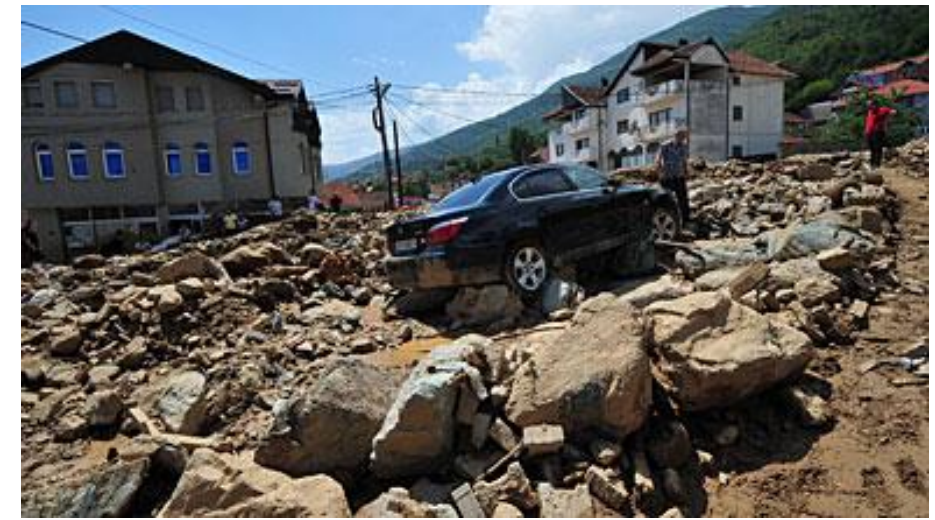
Recent torrent control works

- Only regulation of the torrent in the urban area in the valley
- No upstream measures nor hydraulic nor biotechnical.

DECEPTION of VOTERS before ELECTIONS
ENGINEERING DOUBT – Absence of knowledge

- Lack of knowledge especially difference between river and torrent hydrology in the recent period cause designing of not appropriate structures, absence of upstream measures and channel dimensions that cannot accept the flood wave.

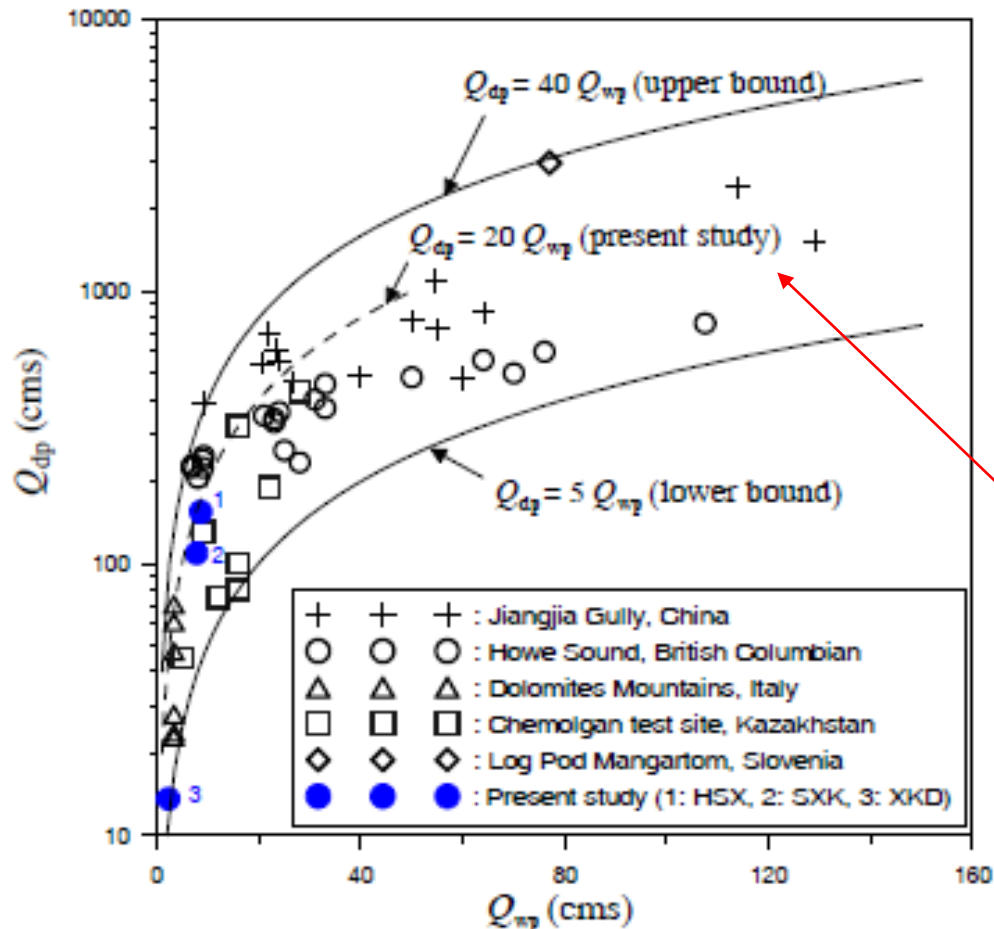
Debris flow discharge vs Water flow Discharge - Q_{dp} vs Q_{wp}

- Definitely, the debris flow discharge differ from water flow discharge. The debris-flow discharge is an important variable when designing debris-flow mitigation structures such as culverts, flumes, bridges, debris-flow barriers, and check dams.

- It is very complicate to define the debris flow discharge. There are various methods.
- The relationship between Q_{dp} and Q_{wp} was widely used in engineering planning because Q_{wp} , which is related to the return period, can be easily determined by hydrologic analysis. The assumed Q_{dp} is proportional to Q_{wp} and is expressed as $Q_{dp} = cbQ_{wp}$, where cb is the discharge coefficient of the debris flow.
